PUBLIC ROADS

A JOURNAL OF HIGHWAY RESEARCH

Page
Structural Efficiency of Transverse Weakened-Plane Joints	83
Disintegration of Bridge Concrete in the West	98
The Federal-Aid Highway Act of 1944	112

STRUCTURAL EFFICIENCY OF TRANSVERSE WEAKENED-PLANE JOINTS

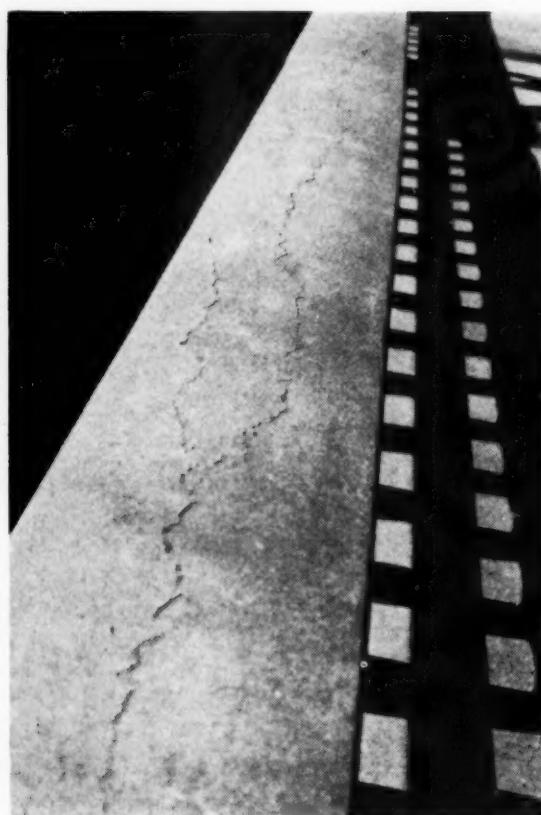
FIGURE 12.—AN EXAMPLE OF TYPE 4 DETERIORATION IN WASHINGTON SHOWING THE LONGITUDINAL TYPE OF OPEN CRACK.
